International Conference on Space Optics—ICSO 2020

Laser-induced damage and contamination testing for the next generation of LIDAR space optics

Nils Bartels^{*a}, Paul Allenspacher^a, Thimotheus Alig^b, Istvan Balasa^b, Helmut Schröder^a, Gabriele Taube^a and Wolfgang Riede^a

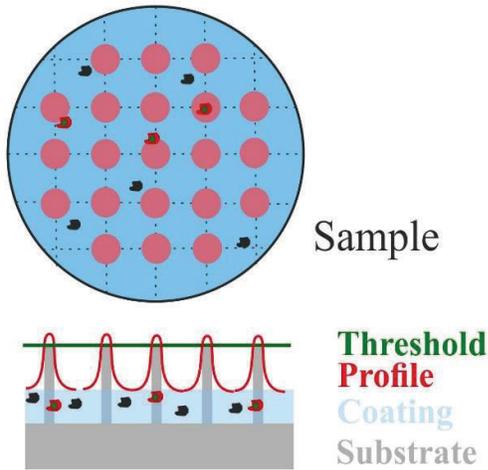
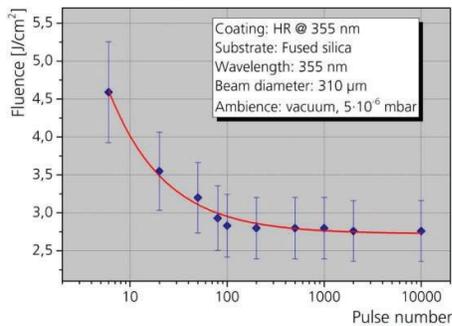
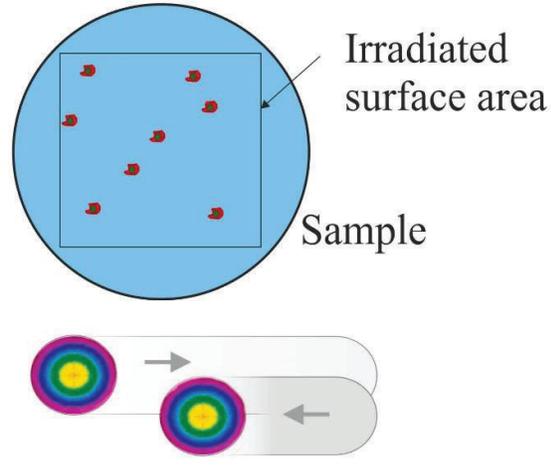
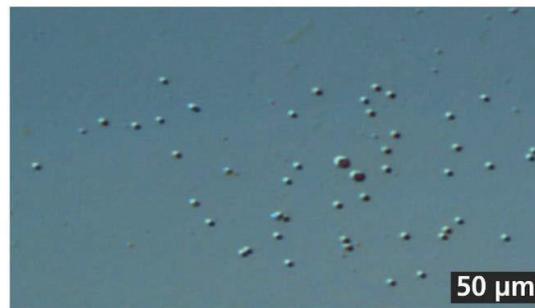
Figure 1: Comparison of test procedures for laser-induced damage testing.

Interrogation of specific test sites
Result: Damage threshold (LIDT)

Interrogation of a large area at specific laser fluence
Result: Damage density (and size distribution)

In order to be able to optimize parameters of the particle mitigation schemes it was necessary to perform damage tests that provide statistically significant data on the damage resistance of the laser optics. A typical S-on-1 test according to the ISO 21254 standard [6] only covers an effective area of 1mm². In particular for high quality optical components (e.g. IBS-coated super polished substrates) this may be insufficient for detecting low density damage precursors. To overcome this limitation, we instead use large area raster scans [7, 8] with an area of 60 mm². In these tests, the laser focused to a specific energy density is scanned over the optical surface. The irradiated area is then analyzed with differential interference contrast (DIC) and dark field (DF) microscopy.

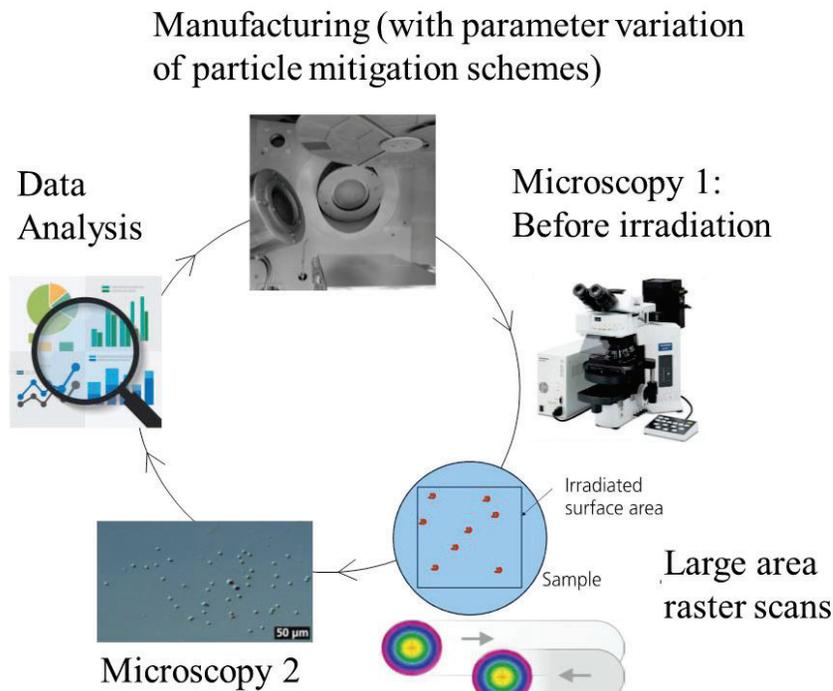
Figure 2: Test strategy for the coating optimization.

We decided to test the manufactured optical coatings with large area raster scans on an area of 60 mm² using two different laser fluences: 15 J/cm² and 25 J/cm². The setup used for laser-induced damage testing at DLR was described previously. [10] Briefly, the third harmonic (355 nm) of a pulsed Nd:YAG laser (Innolas DPSS 500, pulse repetition rate of 100 Hz, 8.2 ns pulse duration at 355 nm (FWHM)) was focused to the optics under test giving a near-Gaussian beam profile with a typical beam diameter ($1/e^2$ -diameter of a Gaussian fit) of 300 μm. The laser light was irradiated line-by-line with a number of 10 pulses per effective Gaussian beam area by adjusting the forward feed of the sample holder mounted to a bidirectional translation stage. The high scanning speed (meaning a low number of laser pulses per area) in combination with an online damage detection system minimizes damage growth due to the subsequent irradiation of laser-induced damages. Before and after each raster scan, the optical surface was investigated via differential interference (“Nomarski”) and dark field microscopy using an Olympus BX61 microscope at 200x magnification. Due to the large surface area and the high magnification the stitched micrographs had a fairly large size of ~4 GPx (“giga pixels”), which corresponds to the size of approximately 167 image files from modern digital cameras (assuming an image size of 24 mega pixels). The large size of the images requires an efficient and automatic data evaluation. The test strategy is visualized in Figure 2.

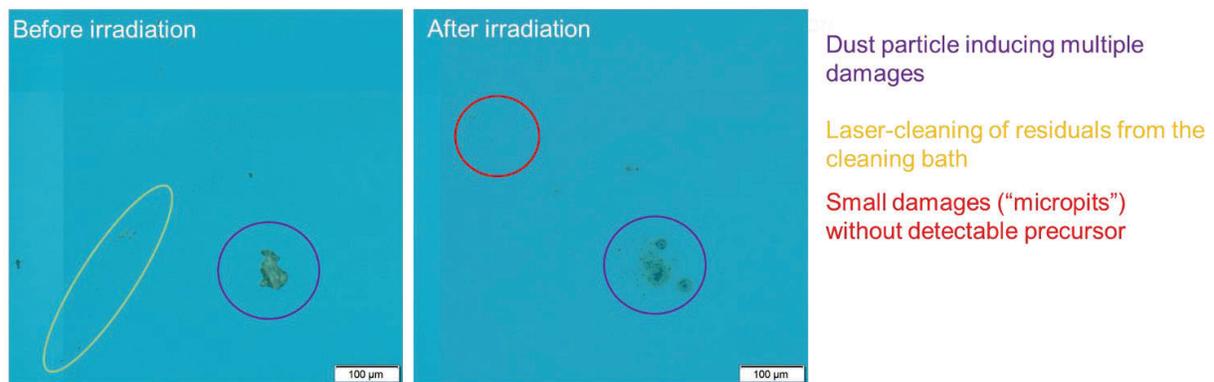
Figure 3: Challenges to classify laser-induced damages.

In principle, one could assume that the number of “damages” can then be calculated by subtracting the number of “defects” (micrograph prior to irradiation) from the number of “defects and damages” (micrograph after irradiation). The issue with this approach is that - in particular for raster scans with a low laser fluence - it can easily be obscured from effects such as laser-induced cleaning (e.g. cleaning residuals from the cleaning bath [10]) or a large number of laser-induced damages induced by a single small dust particle, which can be encountered even in a clean room environment. Figure 3 shows examples of such low probability but sometimes nonetheless important effects.

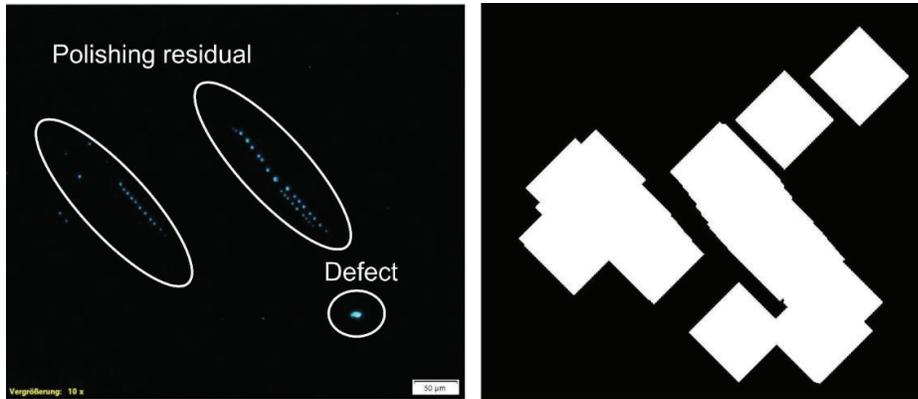
Figure 4: Masking of a polishing residual and a defect in the data evaluation.

In order to find an easily accessible metric to assess the damage resistance of the optical coating neglecting such effects, we decided to additionally look for “damages without detected precursor”. Here, “damages without visible precursor” mean damages that were generated in an area on the optical surface without any defect in its vicinity prior to the raster scan (the minimum distance was defined to ~50 μm). In practice, this was achieved by a masking algorithm. This algorithm detects defects in the dark field images taken before irradiation (left panel of Figure 4). The area around any detected defect is then not taken into consideration when counting the number of damages in the dark field micrograph taken after laser irradiation (right panel of Figure 4).

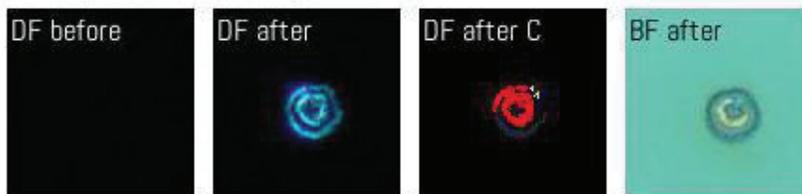
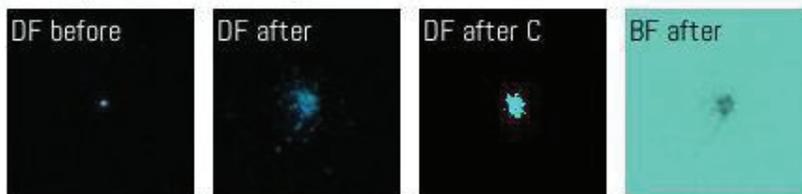
Standard Optics #015, Damage 4

Size (@25 J/cm²): 270Pixels, (x,y)=(11538,1532)

Standard Optics #015, Damage 7

Size (@15 J/cm²): 80Pixels, (x,y)=(15425,5743)

Figure 5: Examples of laser-induced damages. The top picture of Figure 5 shows an example of a laser-induced damage without visible precursor, whereas the damage in the lower picture was generated near a visible defect. Images labeled with “DF before” and “DF after” are dark field micrographs taken before and after the raster scans, respectively. Images labeled “DF after C” show the result of the image analysis in which the connected pixels with an intensity above a specific threshold are colorized. Finally, the images labeled “BF, after” are Nomarski micrographs taken after irradiation.

The final results of the Python script are then a list with the number and size of objects detected prior to laser irradiation (“the number of defects”), a list with the number and size of objects detected after irradiation (“the number of defects and damages”) and the number and size of “damages without visible precursor” obtained using the masking algorithm. In addition to that, an image file comparing microscopic images at a specific position (taken before and after irradiation) is generated for each object. Examples of these automatically generated images are provided in Figure 5.

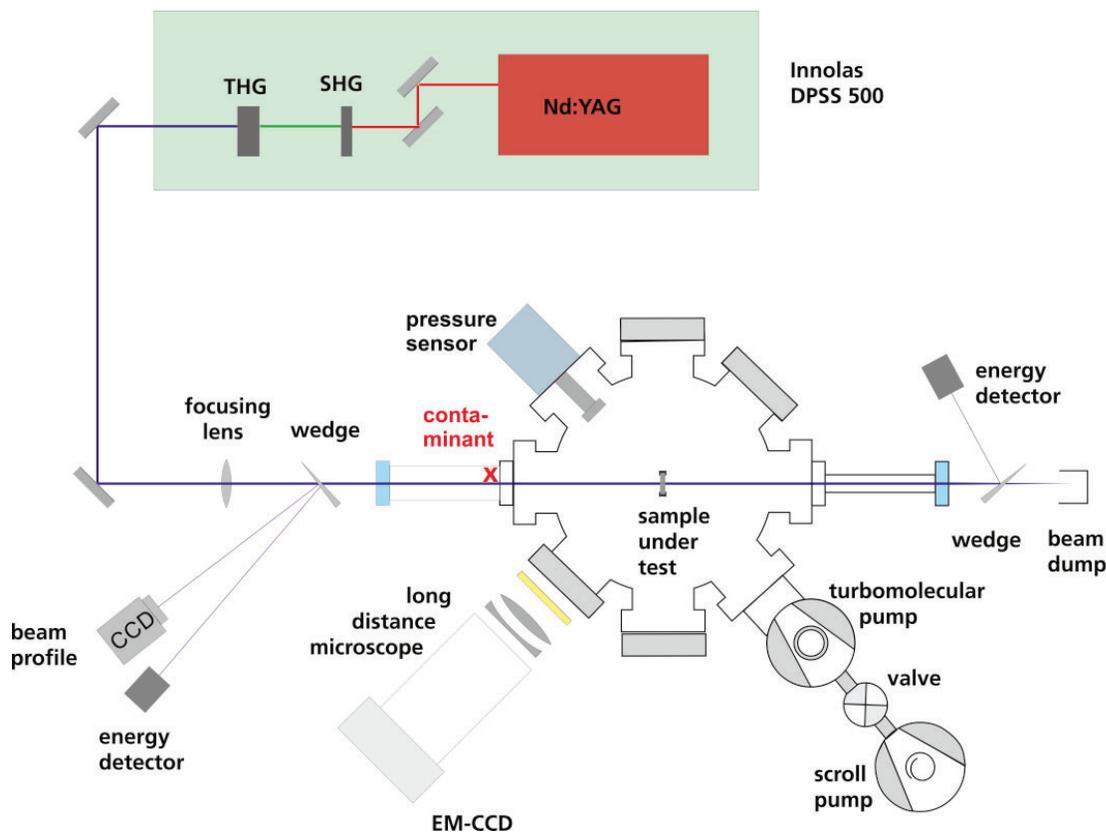
Figure 6: Schematic of the experimental setup for laser-induced contamination testing at 355nm.

We compared the susceptibility of standard IBS coatings to optics that were optimized for laser-induced damage (using ion etching with conditions similar to optics #027) in a test setup as depicted in Figure 6.

In these tests, the sample is placed in a vacuum chamber ($<10^{-6}$ mbar base pressure) and is irradiated for ~ 20 hours with the 355 nm, nanosecond-pulsed laser system also used for LIDT testing. As contaminant, the glue Armstrong A-12 (Loctite, Henkel Corporation, USA) on alumina foil was tested. The contaminant was heated to 100°C to enhance the outgassing and thus to speed up the deposit formation. The contamination growth was monitored in-situ by detecting the laser-induced fluorescence with a long-distance microscope and an electron multiplying CCD detector. Additional LIC tests have also been performed at the fourth harmonic of the Nd:YAG laser at 266 nm. The $1/e^2$ beam diameter was ~ 440 nm for LIC tests at 266 nm and ~ 620 nm for LIC tests at 355 nm.

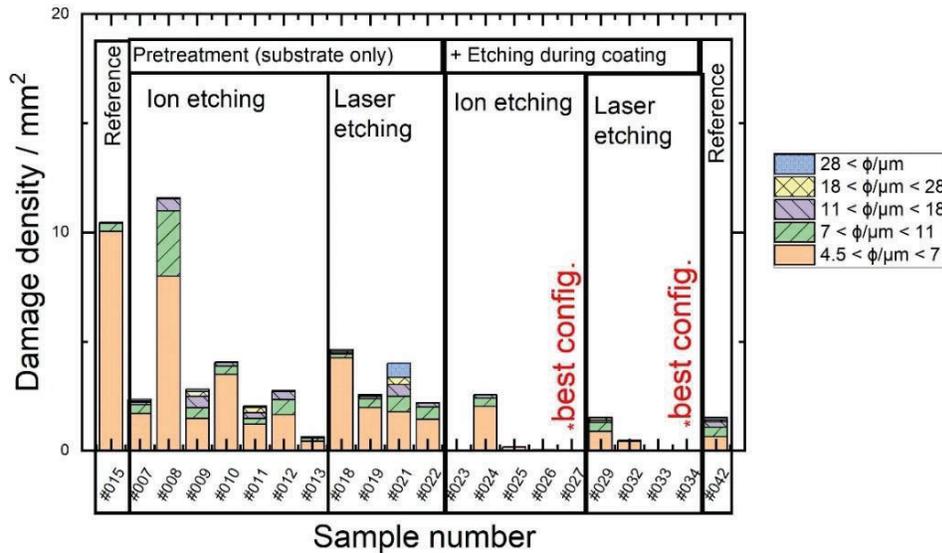
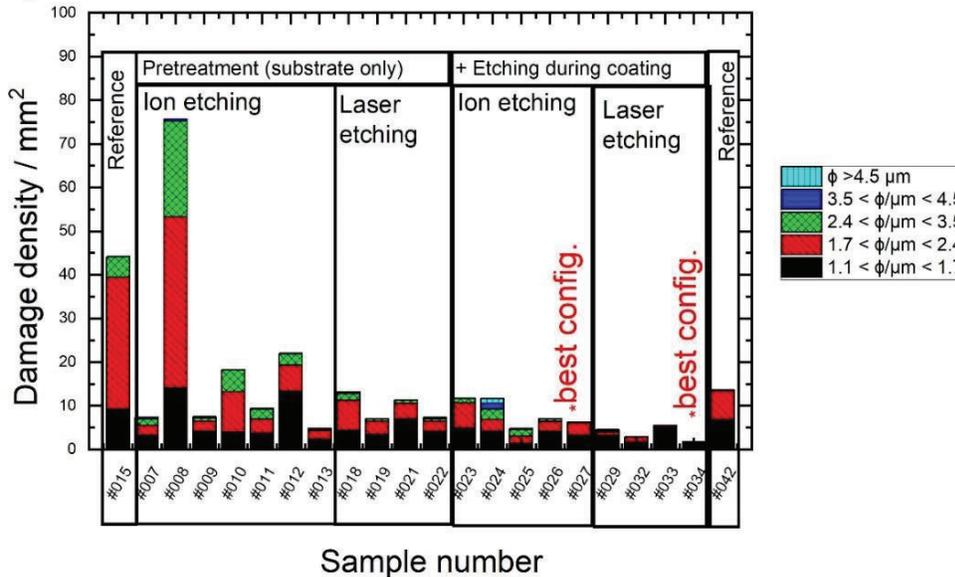
Figure 7: Improvement of the detected damage density during the optimization process of the particle mitigation scheme.

Figure 7 shows the number of damages (more precisely the number of “damages without detected precursor” as defined in section 2.3) for large-area raster scans with an energy density of 25 J/cm^2 (panel A) and 15 J/cm^2 (panel B). In the beginning we tested applying the particle mitigation techniques only to the substrate and not during the IBS sputtering process. Substrates of samples #007 to #013 were treated via ion etching and we varied the ion current (100 -300 mA), the ion energy (100-400 eV) and the incidence angle of the secondary ion source. Substrates of samples #018 to #022 were treated via laser etching and we varied the laser fluence and the scanning speed of the galvano scanner directing the etching laser beam to the sample. However, both methods showed no significant reduction of the damage density compared to the reference samples.

In contrast to this, optics in which the particle mitigation techniques were not only applied to the substrate, but additionally also during the IBS coating, a strong reduction in the damage density was obtained for both the ion etching (samples #023 to #027) as well as for the laser etching (#029 to #034). For specific configurations (sample #027 and #034) optics could be obtained that showed no laser-induced damage with a diameter greater than $4.5 \mu\text{m}$ when tested in a raster scan at 25 J/cm^2 . It should be noted, that this improvement of the optical coatings is not only visible in the “damage density without visible precursor” as indicated in Figure 7, but also in the number of detected “defects and damages”. For the interested reader, these results are provided in the appendix. Additionally, the improvement of the damage threshold has also been demonstrated in ramped raster scan tests as reported earlier. [9]

A) Raster scans at 25 J/cm^2

B) Raster scans at 15 J/cm^2

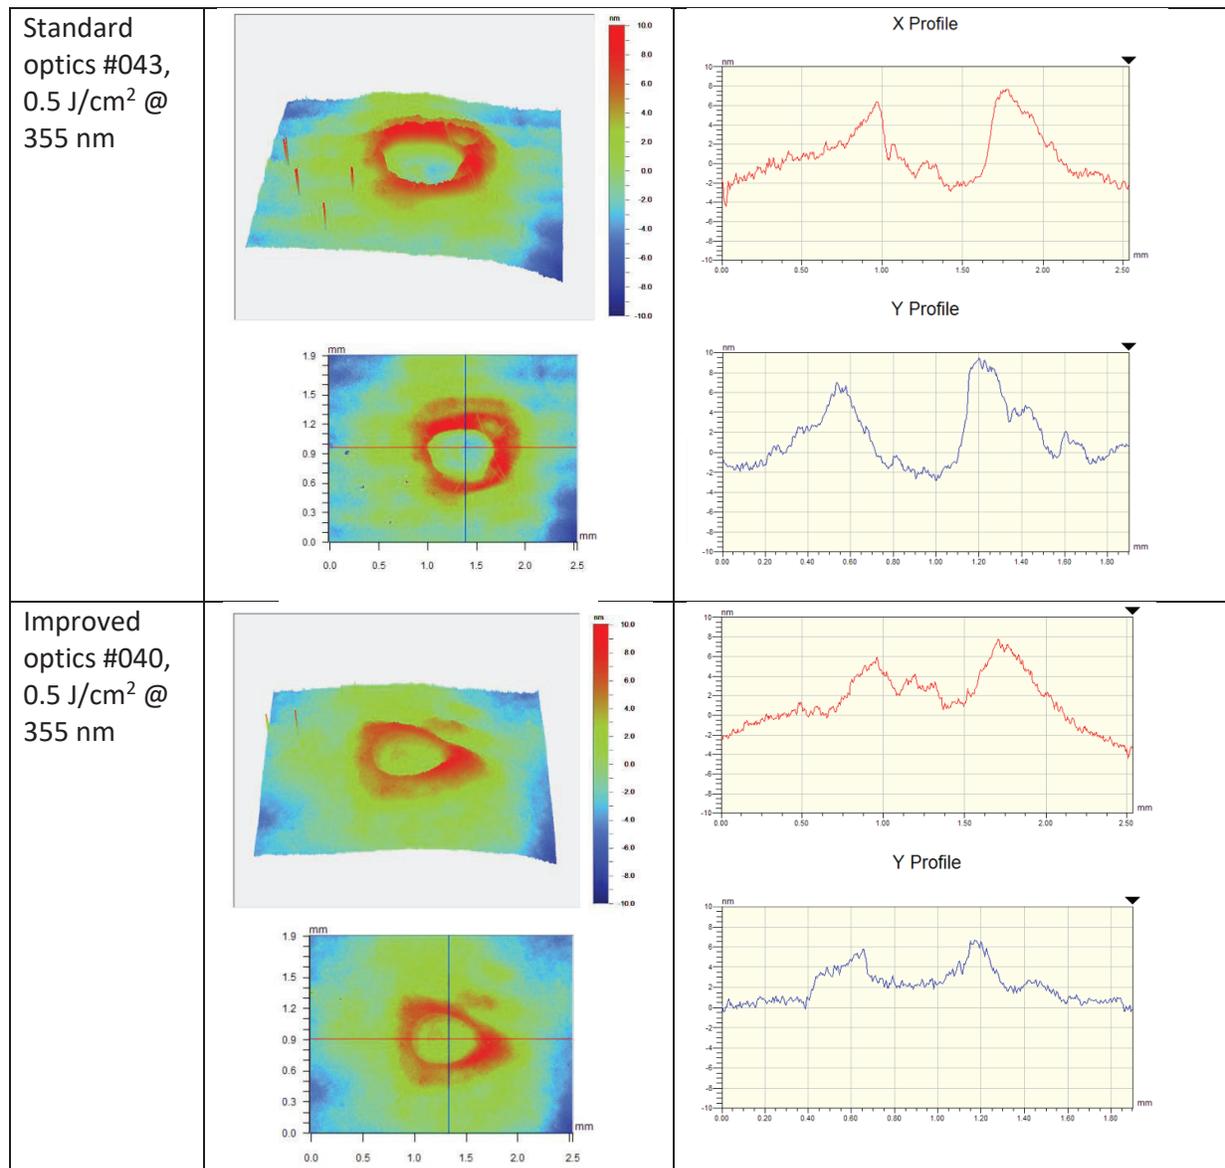
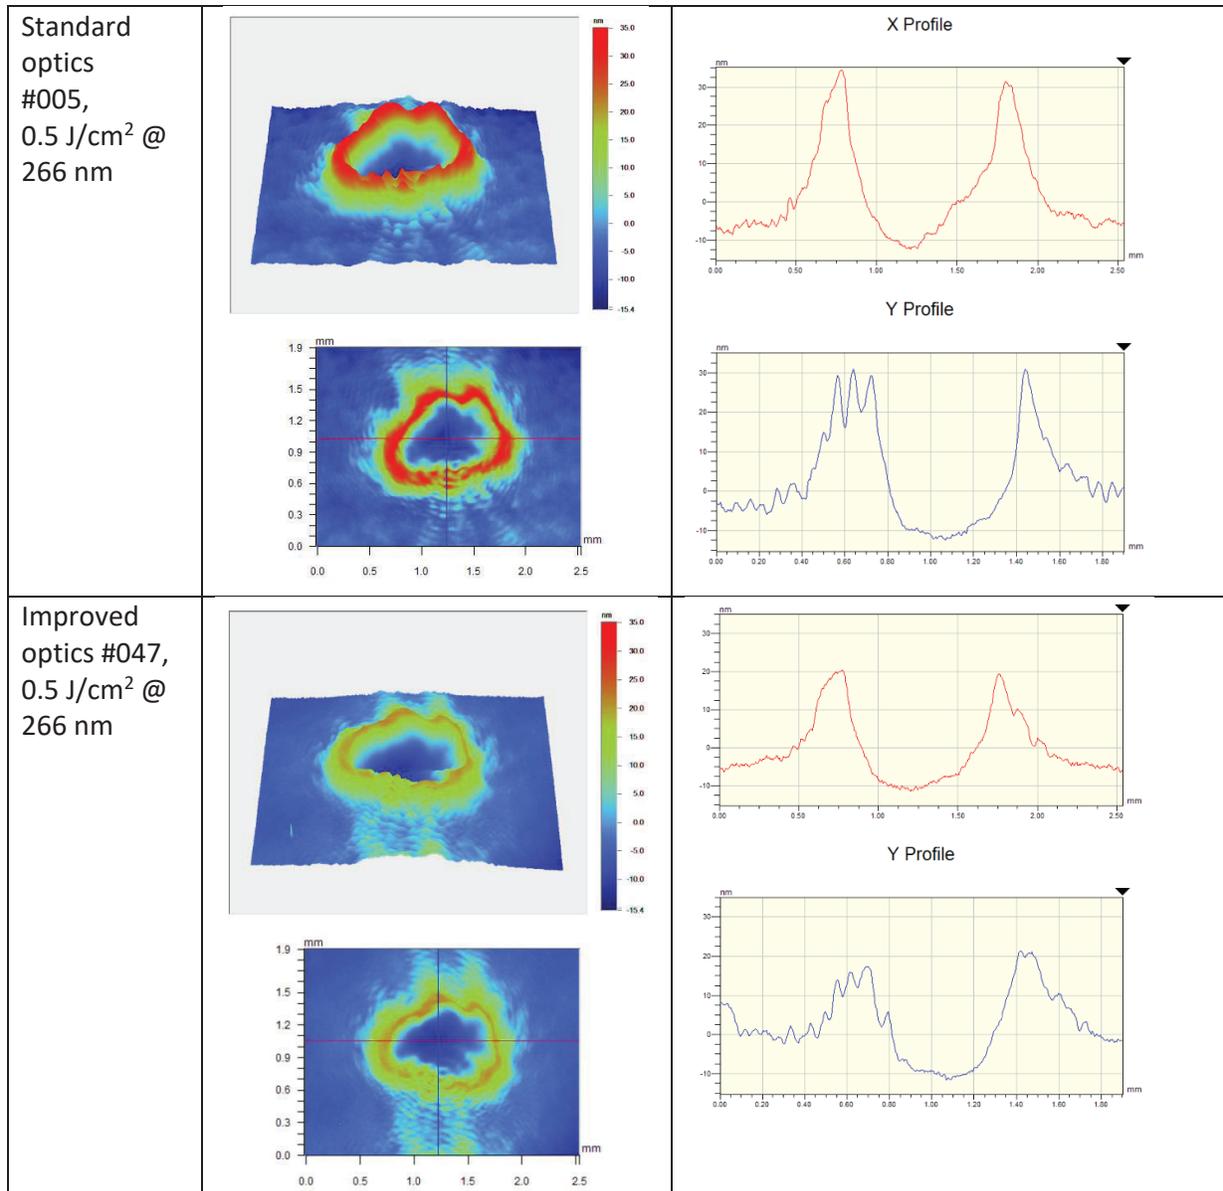
Table 1: Height profiles of laser-induced deposits generated in LIC tests with Armstrong A12 with a laser fluence of 0.5 J/cm².

This was tested in LIC tests with the epoxy adhesive Armstrong A12 (~600 mg per LIC test) at energy densities of 0.5 and 1 J/cm² and for the two wavelengths 355 nm and 266 nm. The test duration was ~20 hours and the contaminant was heated to 100°C in the vicinity of the optics under test. Table 1 shows the height profiles of LIC deposits after tests with a laser fluence of 0.5 J/cm². Similar results for 1.0 J/cm² are given in Table 3 in the appendix.

1. All deposits show the typical “donut-shape” morphology [13, 14, 15]. The lateral dimension of these deposits extends beyond the $1/e^2$ beam diameter of the LIC generating laser (~620 nm for LIC tests at 355 nm and 440 nm at 266 nm, respectively). This has recently been attributed to a thermally induced deposit growth driven via heat conduction from an absorbing (compacted) central part of the deposit. [16]

2. The deposits generated by the 266 nm laser have a much greater deposit height (~30 nm to 40nm) compared to the deposits generated at 355 nm (~10 nm). This can probably be attributed to stronger ability of the 266nm laser (4.66 eV photon energy @ 266 nm versus 3.49 eV @ 355nm) for breaking molecular bonds. A typical C-C chemical single bond has a binding energy of 3.6 eV and a C-H bond has a binding energy of 4.2 eV. This also means that it would be very challenging to build a nanosecond-pulsed LIDAR space laser operating at 266 nm.

- Unfortunately, the laser optics that were optimized with respect to their LIDT via ion etching (“Improved optics”) showed fairly similar deposit heights compared to the optics manufactured via conventional ion beam sputtering (“Standard optics”). It should however be noted, that UV anti-reflective IBS coatings (as tested in this work) are generally much less susceptible to LIC when compared to porous coatings (e.g. e-beam coatings). [18] For example, we have recently tested an e-beam coating with Armstrong A12 (355 nm, 100 Hz, 0.4 J/cm², 100°C contaminant temperature) and obtained a deposit height of ~160 nm after only 1 hour of irradiation.

In principle, the formation of any laser-induced deposit should be considered as a laser-induced surface damage, defined in the ISO-21254 standard as “any permanent laser radiation-induced change of the surface characteristics of the specimen...”. Indeed, the deposits as shown in Table 1 will induce a significant transmission loss (a few percent) of the AR coating and modify properties of the transmitted laser beam (e.g. the beam profile and the wavefront).

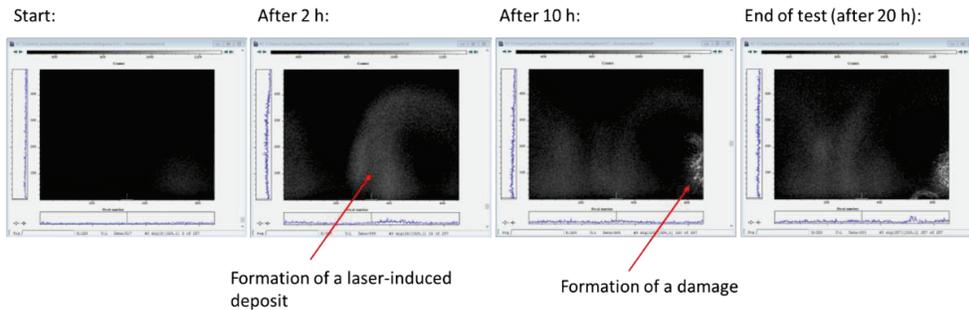
Figure 8: Formation of a laser-induced contamination and subsequently a contamination-induced damage monitored via in-situ fluorescence microscopy.

The continued irradiation of a laser-induced deposit can however also lead to the formation of a plasma and thus to an additional modification of surface or bulk material. [17, 18] In fact, this was observed in one LIC test on an improved laser optics at 355 nm resulting in a contamination-induced damage at a laser fluence of 1 J/cm² (all other optics remained undamaged during LIC testing). From in-situ fluorescence microscopy it can be concluded that this damage was formed in the center of the deposit after ~10 hours of irradiation (see Figure 8).

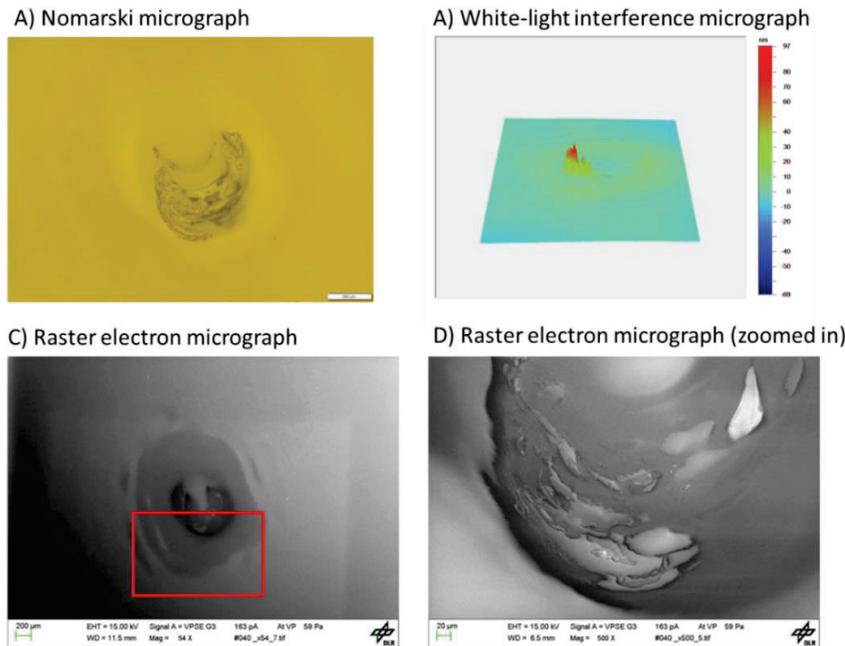
Figure 9: Microscopic images of the contamination/laser-induced damage.

A subsequent inspection of the optical sample with Nomarski and raster electron microscopy showed that material was melted and distributed over the irradiated area (see Figure 9). This morphology can only be explained by the formation of a laser-induced plasma that locally heated the material above the melting point.

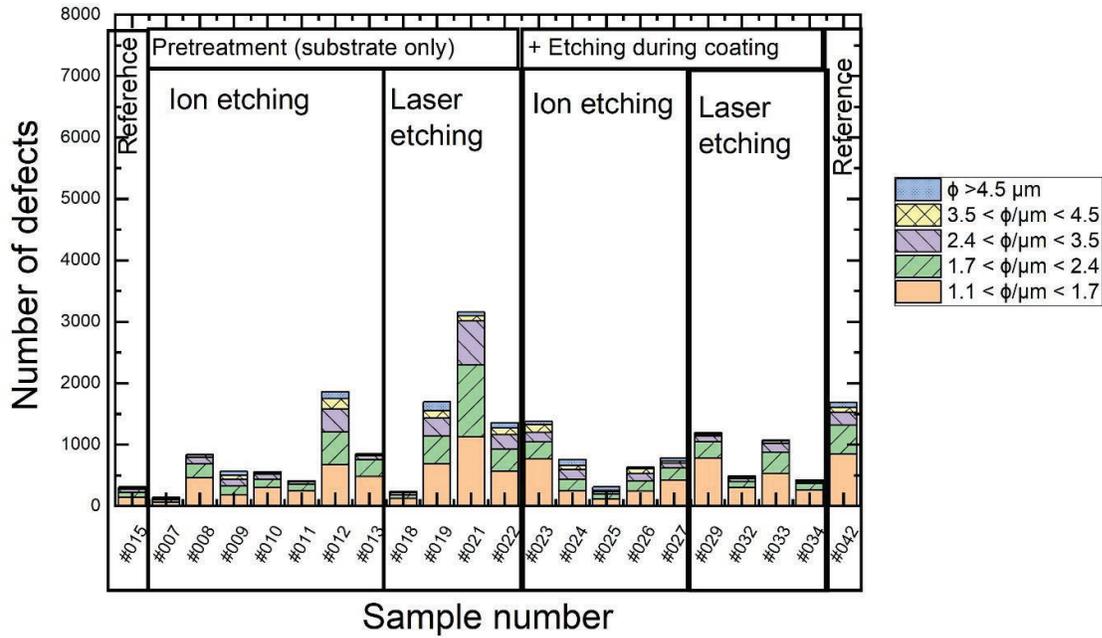
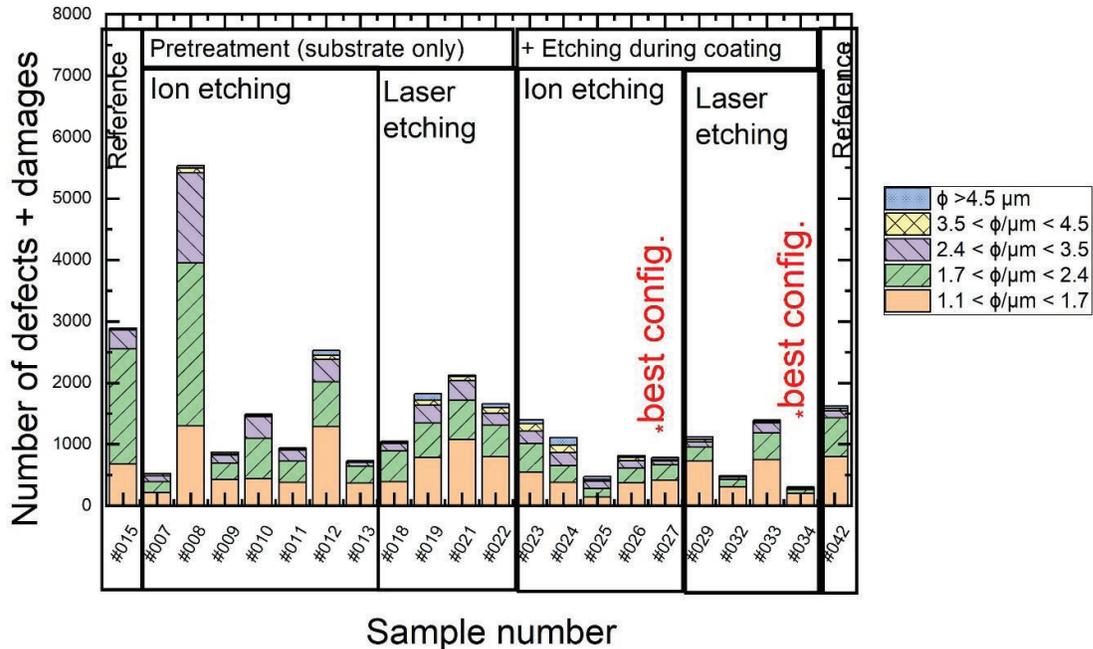
Figure 10: Detected number of objects before the raster scan (number of defects, panel A) and after the raster scan (number of defects and damages, panel B) at an energy density of 15 J/cm².

A) Before raster scan

B) After raster scan at 15 J/cm²

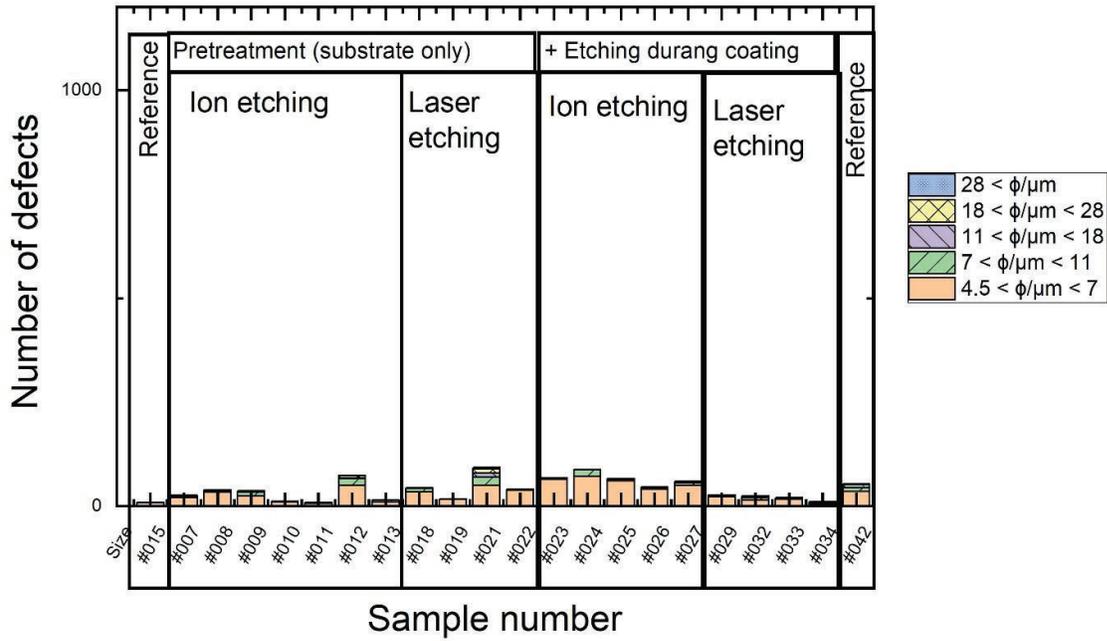
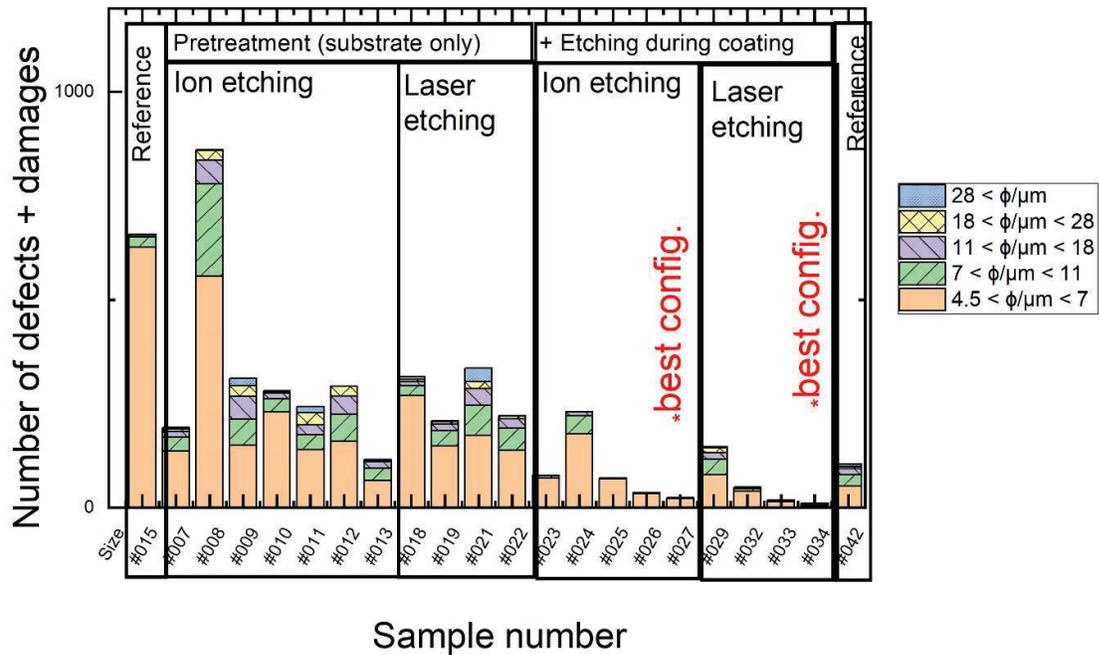
Figure 11: Detected number of objects before the raster scan (number of defects, panel A) and after the raster scan (number of defects and damages, panel B) at an energy density of 25 J/cm².

A) Before raster scan

B) After raster scan at 25 J/cm²
