Passive Sensors for Infrastructure Monitoring

ABSTRACT

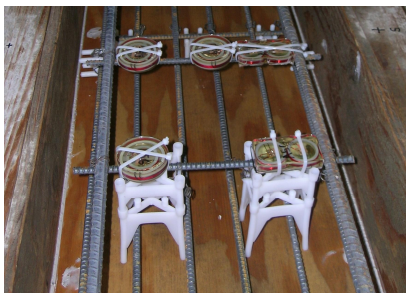
Figure 6: Plastic chairs were used to support the layers of reinforcement independently in Slabs 1 and 2.

- Eight corrosion sensors of an alternate design were also embedded in Slabs 1 and 2 (shown on the right side of Fig. 6). The sensing and reference coils were adjacent in this design, but the amplitude of the measured response was considerably lower for this configuration. This arrangement of coils was subsequently rejected⁸; therefore, the response of the sensors with adjacent coils is not addressed in this paper.
- Fourteen threshold corrosion sensors (Fig. 9b) were attached to the top layer of reinforcement in Slabs 3 and 4. All sensors were fabricated using 21-gage steel wire. Sensing wires were attached to the top layer of reinforcement (Fig. 11).
- Four analog conductivity sensors and five thermocouples were also embedded in Slabs 3 and 4 (shown in the center of Fig. 7). The response of these sensors is discussed elsewhere^{9,10} and is beyond the scope of in this paper.

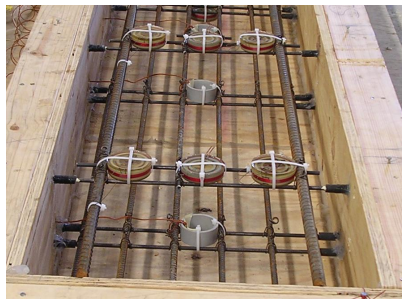
Figure 7: Top and bottom layers of reinforcement were supported independently on the transverse reinforcement in Slabs 3 and 4.

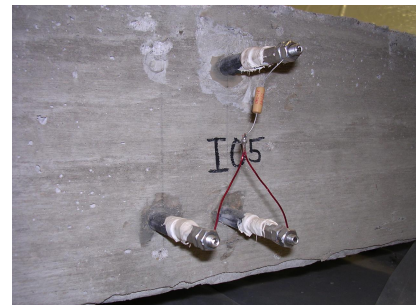
Figure 8: Layers of transverse reinforcement extended beyond the concrete in Slabs 3 and 4.

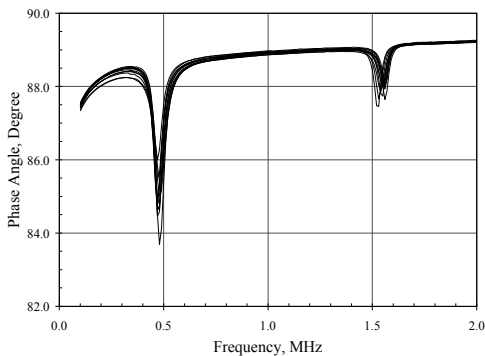
(a) Twelve sensors with intact sensing wires

(b) Two sensors with corroded sensing wires

Figure 20: Response of sensors embedded in Slab 4 in April 2007.

Connecting the steel sensing wire to the top layer of reinforcement was not successful in increasing the tributary area for the threshold sensors. However, the number of sensors that exceeded the corrosion threshold within the region of highest risk (Fig. 19a) did increase as the length of the exposure test increased. The frequency response of the passive sensors at the conclusion of the exposure tests is shown in Fig. 20 and 21 for Slabs 4 and 3, respectively.

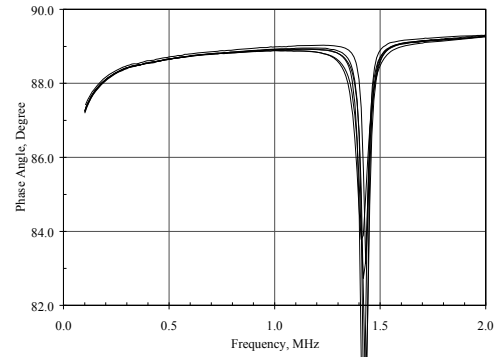
(a) Eight sensors with intact sensing wires

(b) Six sensors with corroded sensing wires

Figure 21: Response of sensors embedded in Slab 3 in February 2009.
