# New trends in non-destructive assessment of aerospace structures

The scope of the paper includes non-destructive assessment of the structure's material condition, for the aerospace structures during its useful lifetime. The paper presents multidisciplinary technologies devoted to development and implementation of methods and systems that realize inspection and damage detection by non-destructive methods.

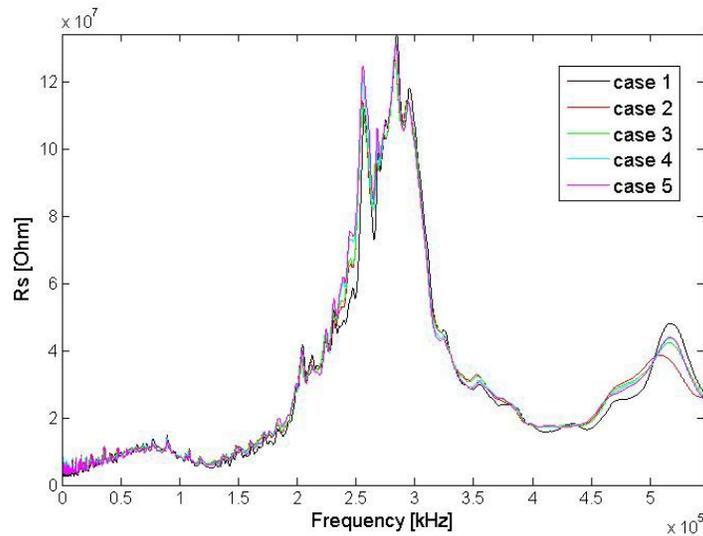
The moisture influence was observed in the real part of electrical impedance (resistance) in range 0-550 kHz (Figure 1). The increasing moisture level caused shifts of the peaks to the left. Peaks in the real part of the electromechanical impedance are directly related to natural frequencies of CFRP sample [10], [11]. This fact can be related to the reduction of natural frequencies values. Due to moisture uptake sample mass increases what results in reduction of natural frequency values. On the other hand moisture content allow to reduce stiffness what also reduces natural frequency values [12]. Moisture content causes degradation of elastic modulus.

Figure 1. Real part of electrical impedance spectra of piezoelectric transducer for moisturized sample.

Analyzing the frequency shifts in the vicinity of 285 kHz (Figure 1) it can be noticed that plot of spectra for the case number two (after thirteen days moisture uptake) is shifted to the left (by 1700 Hz) in comparison to the spectra for sample from case one (dry condition – reference state). In the third case (after one day drying) compared to second case characteristic shift a little bit back to the right (by 200 Hz). After second day of sample drying (fourth case) resistance characteristic is shifted more and also to the right (by 600 Hz). Next for measurements after seven day long drying process measured characteristic is shifted most to the right (by 200 Hz). Finally in the last case frequency of observed peak is placed 700 Hz to the left in relation to the referential state.

Based on these result one can concluded that for increasing level of moisture characteristic of real part of transducer electrical impedance is shifting to the left. For decreasing moisture level characteristic is shifted back to the right. Increasing level of moisture causes reduction of maximum peak amplitude. For decreasing level of moisture amplitude of maximum peak increase almost to the value for referential state. Region around frequency 285 kHz was taken into considerations due to fact that resonance peaks have maximum amplitude in this region. According to [10] frequency band with highest density of peaks is recommended for the analysis.

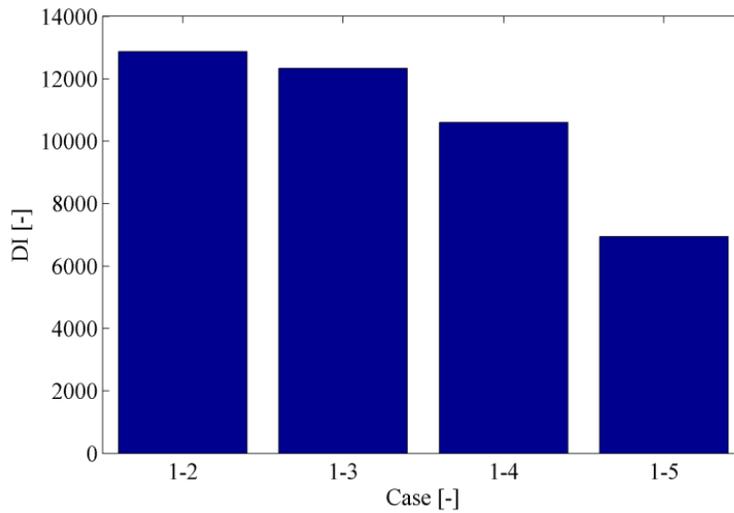
In order to characterize the changes of real part of the electromechanical impedance due to moisture level a deviation index (DI) was utilized [10]. The first case (dry sample) was taken as referential state and next four cases were taken as

unknown states (Figure 2). Deviation index values calculated for whole investigated frequency band presented in figure 1.

Figure 2. Deviation index values for investigated cases.

Largest value of DI was obtained for case 1-2. In this case DI was calculated based on signal for referential state measurements (dry sample) and state of sample taken out of the water after thirteen days. In this case moisture level is highest. Smaller value of DI can be observed for case 1-3 based on measurements taken after one day of drying. Value of DI decrease further for case 1-4 which is related to the measurements after two days of sample drying. The smallest DI value was achieved in the case 1-5 related to the measurements after five days drying.

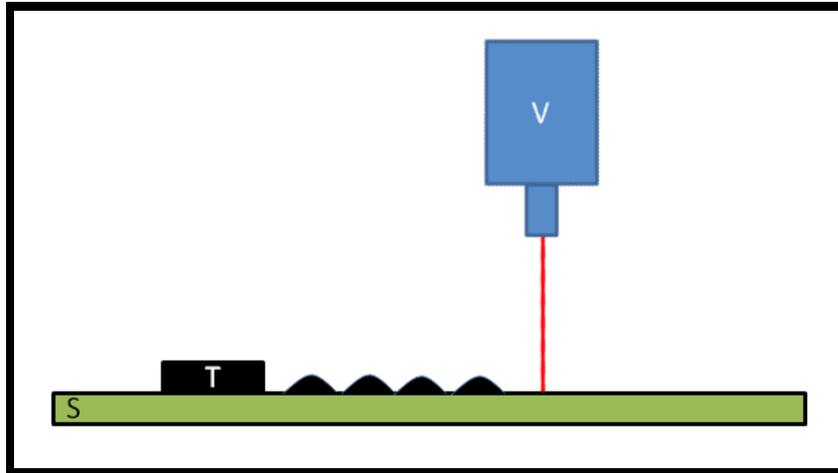
The second investigated method for surface assessment was base on Laser Doppler Vibrometry (LDV) used for guided wave sensing. Vibrometry measurements were conducted with scanning laser vibrometer working in 1D mode (V in figure 3). During the measurement the sample surface (S in figure 3) is scanned by a red laser beam. The samples were excited with a piezoelectric transducer (T in figure 1). The transducer was a disc with diameter: 10 mm and thickness: 0.5 mm (CeramTec, material: SONOX P502). The excitation signal was a tone burst with 5 cycles. The used vibrometer is a scanning device that allowed to measure response at various points at the surface without the need for moving the sample or scanning head.

Figure 3. Measurement scheme for vibrometry method.

The adhesive bonding was also assessed using LDV for measuring guided wave propagation (Figure 3). The LDV methodology was described in previous section related to surface assessment. The sensitivity to weak bond was sought in the value of energy ( $E$ ) and its dispersion over the surface represented by standard deviation ( $\sigma$ ). Figure 10 shows that moisture contaminated samples (MO) clearly differ from the reference. Both chosen parameters ( $E$  and  $\sigma$ ) show a significant increase in comparison to reference (Ref). The poorly cured samples (CS) also differ from the reference (Figure 11). Moreover the lower the curing temperature the difference is growing. In the case of release agent contaminated (RE) samples (not shown in figure) a significant difference was not observed.

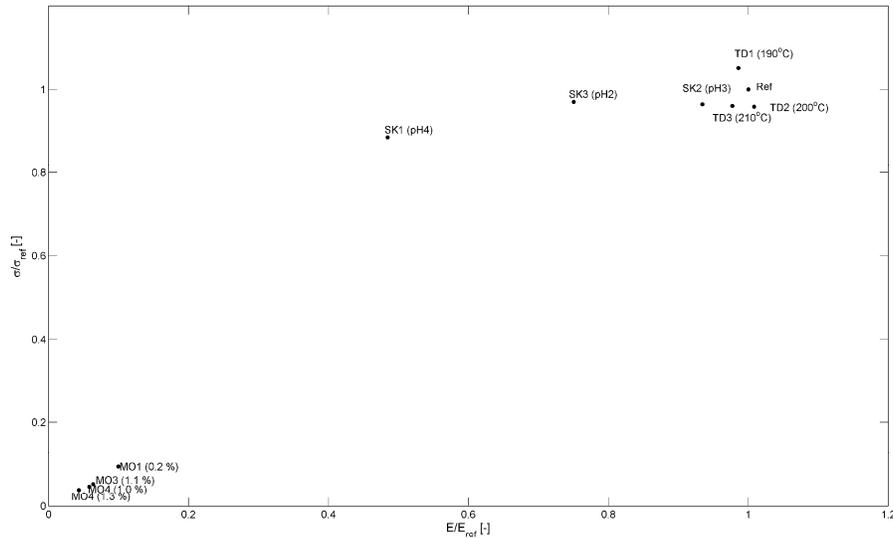
In order to perform surface assessment following signal processing was proposed. At each measurement point an index proportional to squared signal was calculated. This index is proportional to squared voltage and can be associated with out of plane vibration energy. The calculated index was averaged over the whole set of measurement points. The sensitivity to surface anomalies were sought in the value of this energy ( $E$ ) and its dispersion over the surface represented by standard deviation ( $\sigma$ ). Figure 4 shows that some of the contaminated samples clearly differ from the reference. The method clearly indicates the moisture contaminated CFRP samples (MO) – left bottom corner in figure 4. Both chosen parameters ( $E$  and  $\sigma$ ) show a significant decrease in comparison to reference (Ref). The CFRP samples contaminated by hydraulic oil (SK) characterize by slightly smaller  $E$  and  $\sigma$  than the reference sample. The thermally degraded samples (TD) did not differ too much from the reference.

Figure 4. Results for surface characterization using laser vibrometry.

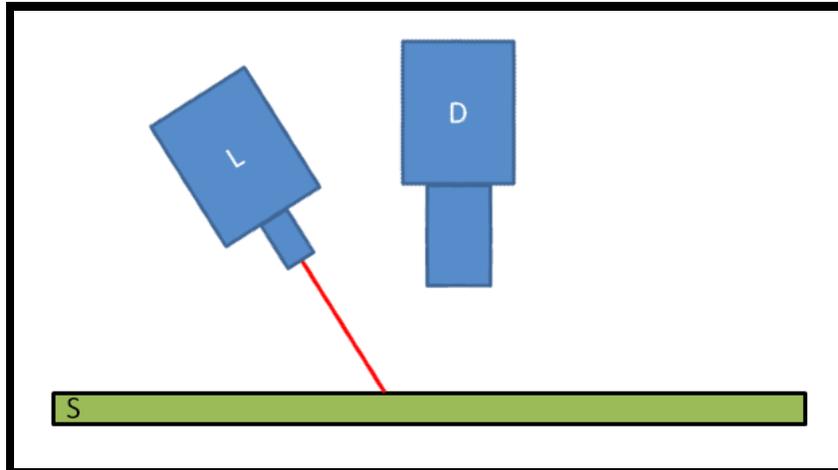
The third investigated method was fully noncontact. In this method Laser Induced Fluorescence Spectroscopy (LIF) was used. The LIF allow to analyze large objects using surface scanning technique with noncontact excitation and sensing [13] (Figure 5). The excitation source (L) is - Nd:YAG, 6 ns pulse, 1064 nm laser equipped with harmonic generation modules: 532 nm, 355 nm and 266 nm. Monochromator is used for the detection of fluorescence (D). The fluorescence spectra are recorded and processed. LIF was used for surface assessment of CFRP specimens. The LIF spectra were recorded for laser excitation at 266 nm, 355 nm and 532 nm. Applied laser intensity for all wavelengths was about 300 J/m<sup>2</sup>. The preliminary studies of the fluorescence shows that applied laser radiation does not cause degradation of investigated material and changes of fluorescence spectra in subsequent measurements. The conducted comparison of the possible excitation showed that for 266 and 355 nm there are no differences in fluorescence spectra between clean reference sample and samples contaminated with hydraulic fluid and release agent. Thermal degradation of the sample also do not caused any visible change. Under excitation at 532 nm, beside narrow band with a maximum at 432 nm (observed also for other excitation – at 266 and 355 nm), a strong fluorescence in a wide band with maximum at 600 nm is observed. The intensity of the wide band fluorescence changes significantly for different samples. The quantitative assessment of the sample surface was based on three parameters – intensity (A), fluorescence lifetime (T) and decay time (t). Fluorescence life time (T) is equal to two standard deviations after fitting a Gaussian distribution to the measured curve. Fluorescence decay time (t) is equal to amplitude drop by e and it is obtained by fitting an exponential curve to the falling slope of the measured curve. The results for SK samples show that the fluorescence lifetime (T) indicates dropping value of T with decreasing pH value. The same behavior can be observed for the decay time (t) [13]. The fluorescence intensity seems to be insensitive to hydraulic fluid contamination. Taking into consideration the TD samples it was observed that with increasing temperature of degradation the fluorescence intensity increases [13]. Due to availability of two samples for 200 and 210°C the reliability of the method was tested. The samples of the same type gave similar result. The increasing intensity in relation to 190°C and reference samples was observed. It should be mentioned that fluorescence lifetime and decay did not allow detect the thermal degradation. Measurements of samples contaminated with release agent solution indicated no sensitivity of the method for release agent contamination level.

Figure 5. Measurement principle of the LIF method.

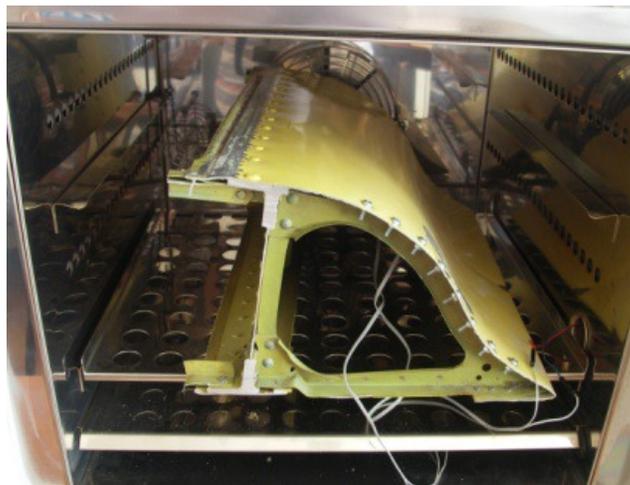
In this section we focus on the NDT of structural bonds. Attention was focused on performance of riveted joints and adhesive bonds of composites. The EMI technique was used for investigation of a aircraft wing section cut off from its trailing edge. The structure was composed of thin and curved upper shell which was originally fixed to the wing ribs and spars by rivets (Figure 6). For the purpose of the experiment one line of rivets was replaced by bolts in order to simulate normal and degenerate behavior of rivets in repetitive manner.

Figure 6. Section of aircraft wing in temperature chamber.

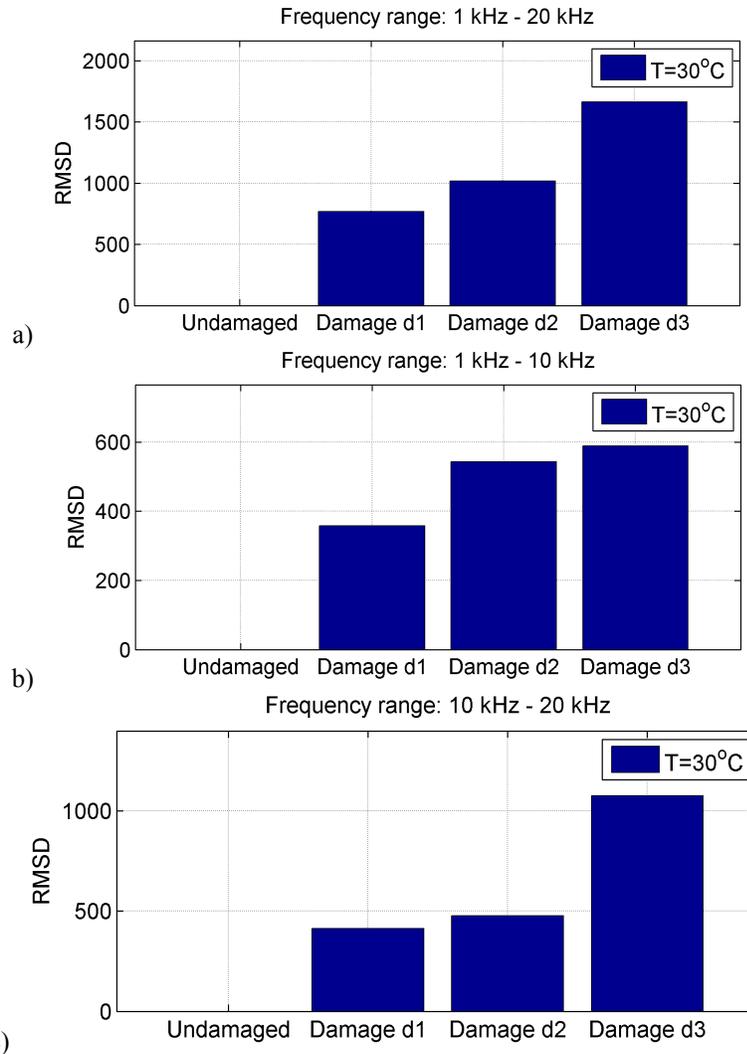
In figure 7 the sensitivity of RMSD to increased level of damage is shown for low (1-10 kHz), high (10-20 kHz) and entire (1-20 kHz) frequency intervals. Damage was introduced by subsequent loosening of three bolts connecting outer shell and internal rib in the section of aircraft wing. For stable temperature level RMSD behaves well regardless the considered frequency interval used for calculation of this damage indicator.

Figure 7. Performance of RMSD as damage indicator for increasing damage – measurements on the section of the wing.

The RMSD based indication gets worse if one considers indication of damage based on two measurements performed at different temperatures. If the reference measurement was performed at 30°C and the damage state measurements at 40°C, The first two cases of damage scenario were obscured by temperature differences. Only the third case d3 had bigger influence on RMSD than temperature variations [14].

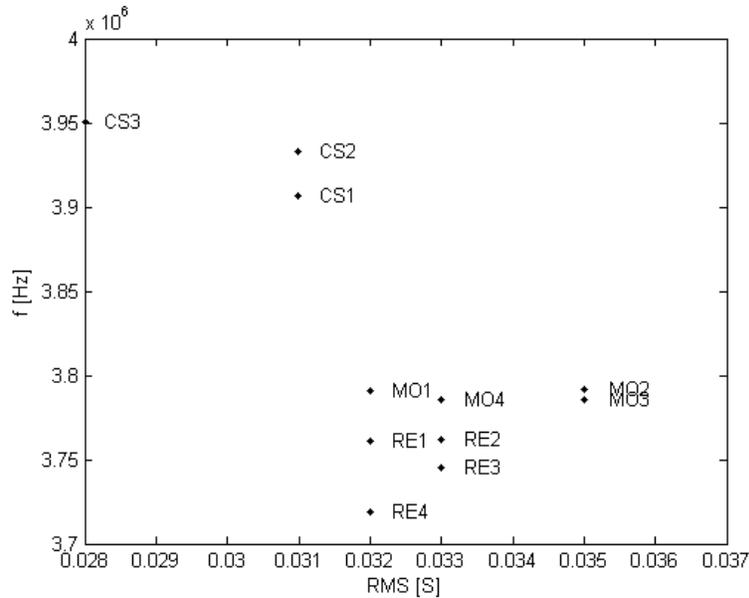
Figure 8. Peak frequency and RMS for the weak bond samples compared with results for sensors and bonded sensors.

The results of calculation of conductance maximum frequency  $f$  and  $RMS$  in band 3-5 MHz are depicted in figure 5. One can notice that  $RMS$  value does not allow for clear classification of different bonding scenario. Looking at the frequencies we do not observe such separation. Only the CS1-3 and MO4\* samples were clearly separated. The frequency values allow to separate some of the results. There is also indication of weak bond condition. This is better visible in figure 6, where one can notice that the decrease in the curing temperature causes the clear increase in  $f$  (CS samples). In the case of release agent samples (RE) the weaker the bond (increase in contamination) the lower the frequency. Moisture samples (MO) are comparable with each other in terms of frequency.

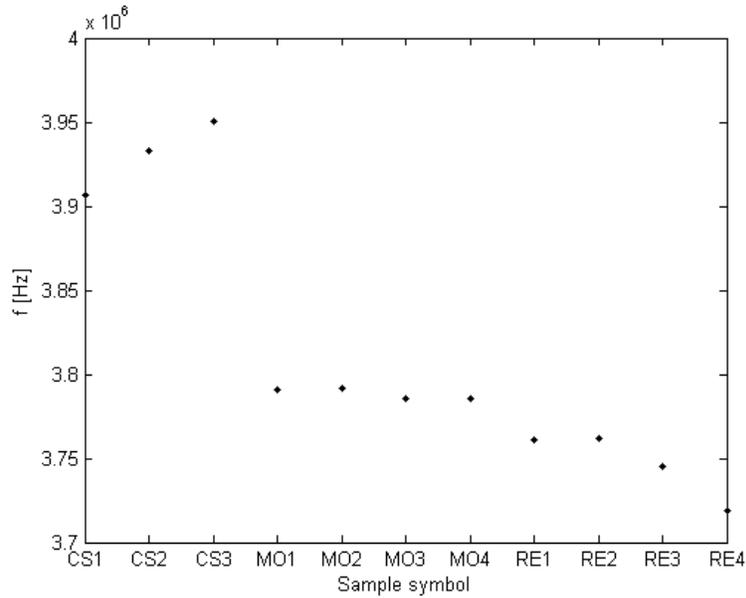
Figure 9. Weak bond influence on the frequency of the conductance peak.

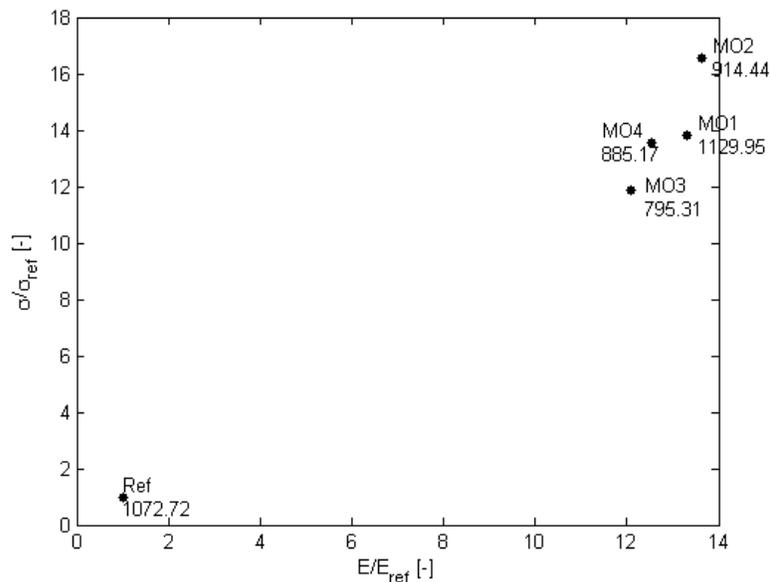
Figure 10. Results for moisture contaminated bonds characterization using laser vibrometer; next to the sample symbol the mean GIC value was provided.

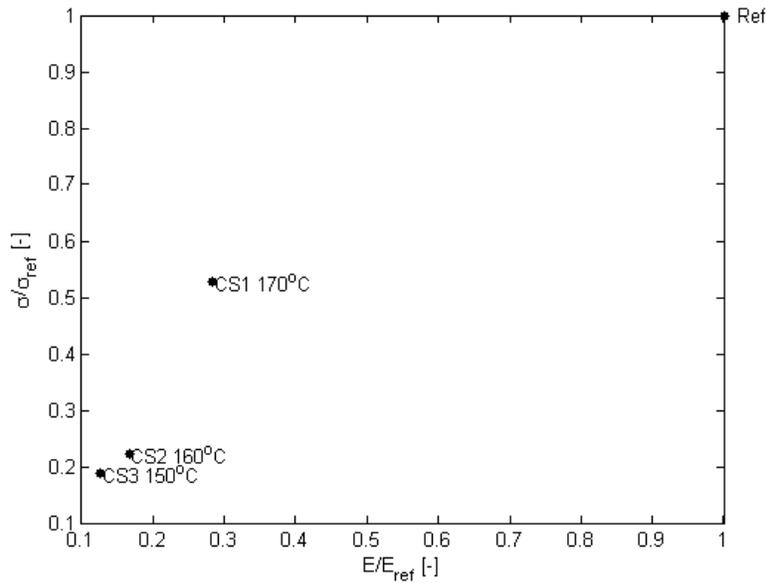
Figure 11. Results for poorly cured bonds characterization using laser vibrometer; next to the sample symbol the curing temperature was provided.

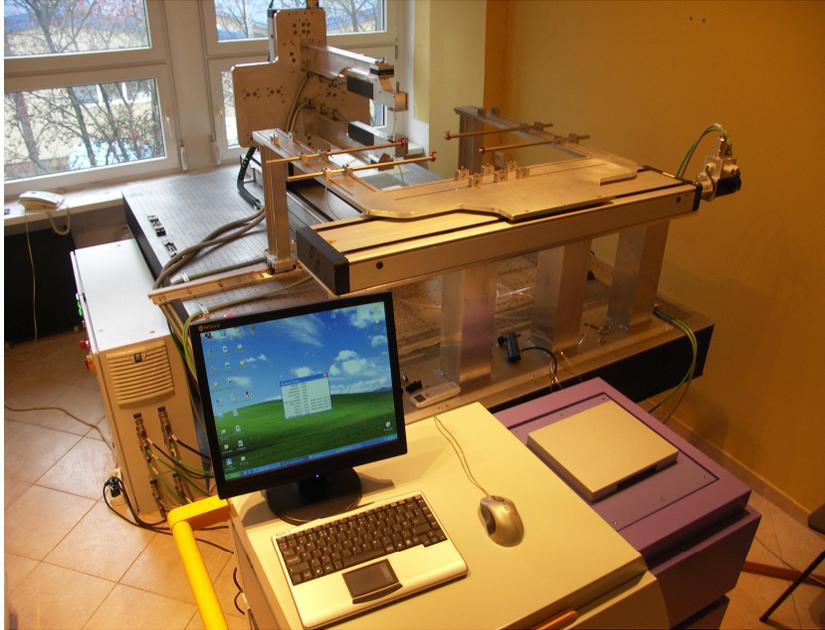
In this section authors focus on methods aimed at damage detection. The first investigated method is the terahertz time-domain spectroscopy (TDS) [15]. This is a spectroscopy in the frequency range from 100 GHz to around 4 THz that has been used in recent years for the purpose of non-destructive material testing. The submillimeter-waves are able to penetrate through many nonconducting materials. At each dielectric interface, e.g. from air to the GFRP material, the electromagnetic waves experience partial transmission and reflection. In this paper, we use the THz-TDS-system as a tool to remotely detect delamination presence. The scanning heads of the THz-TDS-system worked in reflection mode. THz TDS system TPS Spectra 3000+ by TeraView Limited generates radiation in the form of repeated, very narrow picosecond pulses which are focused and sent toward the investigated structure. Wide frequency content, small power and non-ionizing radiation are the main characteristics of the pulse. This approach is very interesting when the material allow for penetration at THz-frequencies, such as GFRP. The experimental setup using THz TDS system is shown in Figure 12. The investigated samples are supported by steel bars mounted to system responsible for the movement in the horizontal plane.

Figure 12. Terahertz TDS spectrometer with scanning unit

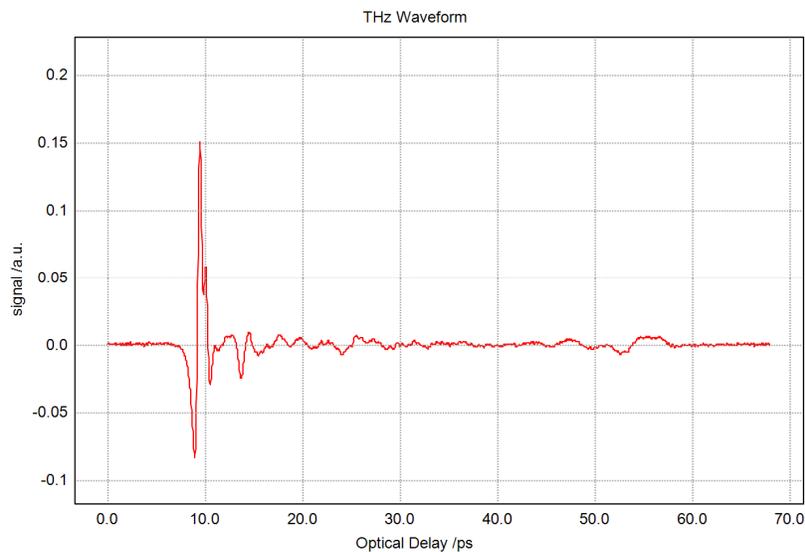
The investigated sample was a GFRP with artificially introduced delamination (Figure 13). The bottom part of the sample was covered with metallic adhesive tape in order to amplify the radiation reflection that can be observed in registered signals. The whole area of the sample was scanned with fine step. The time signal registered for damage free area of the sample is depicted in figure 14. The highest pulse reflected for the upper surface is visible at about 10 ps. There are some subsequent smaller pulse representing the internal structure. The pulse reflected from sample end is visible at about 55 ps.

Figure 14. THz reflection signal registered at damage free area

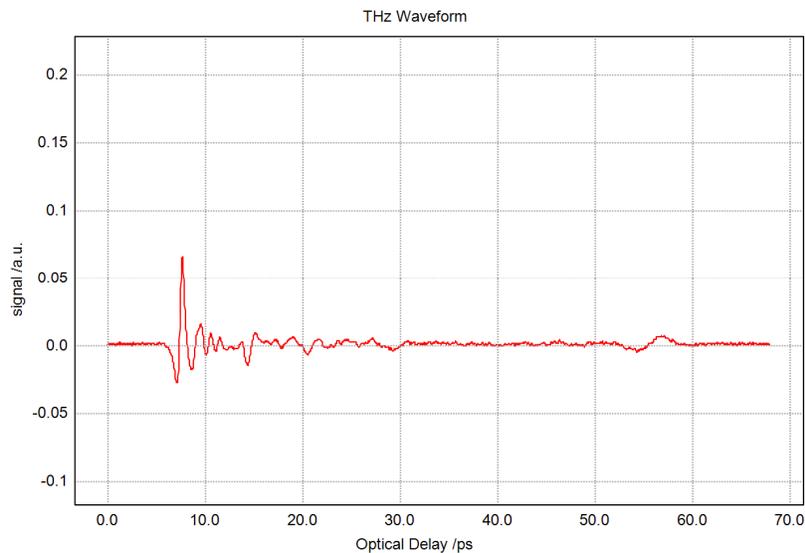
Figure 15. THz reflection signal registered at delamination area

Looking at the terahertz signal for delaminated area one can notice a weak reflection at about 28 ps (Figure 15). This is related to presence of delamination at about half of the cross section. The registered time signals are basis for B-scan and C-scan visualization that is analogous to visualization technique used in traditional ultrasonic testing.

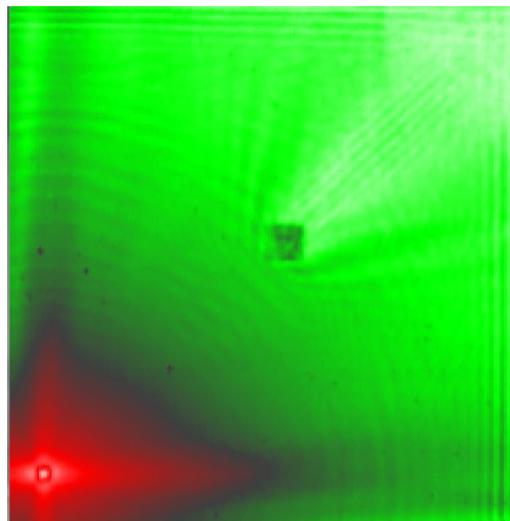
Figure 16. Visualization of delamination location for LDV registered guided waves at 100 kHz; delamination: 20 mm x 20 mm  
THz reflection signal registered at delamination area

The investigated case was a 500 mm x 500 mm x 2 mm CFRP plate with artificial delamination in the form of a teflon insert (20 mm x 20 mm). Only one quarter of it was measured with the scanning LDV. The excitation signal was a 100 KHz tone burst with 5 cycles. The damage detection result is depicted in figure 16. In the left lower corner there is a high value of RMS representing the location of the transducer. The wave scattering at the delamination caused that the RMS values reflect the real rectangular shape of the inserted Teflon (middle part of figure 16).

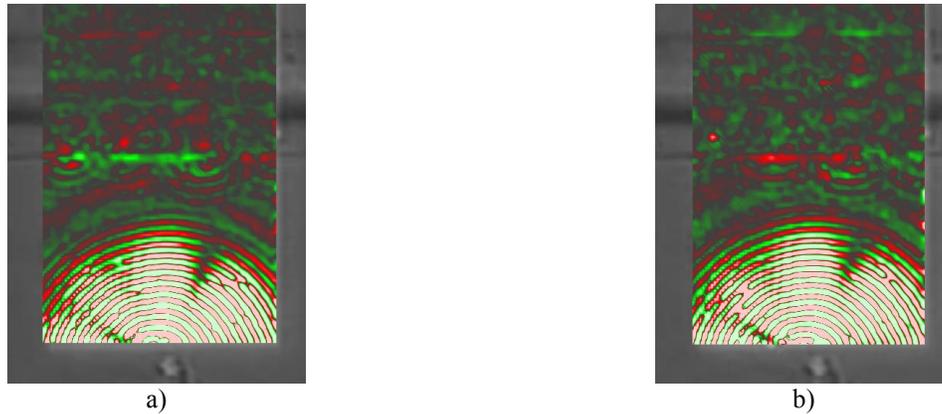
The presence of structure failure can be also visualized by LDV looking at guided wave mode conversion [17]. Authors investigated a aircraft panel with riveted stiffeners. In figure 17 chosen frames from animation of elastic wave propagation in referential panel (a) and a panel with removed rivet (b) were presented. In these frames from wave propagation mode conversion (symmetric to antisymmetric S/A) caused by rivets is clearly visible. What is interesting, after removing of one rivet (location of removed rivet visible in Figure 17b – on the left part of stiffener) mode conversion was not noticed in the place without rivet (please compare figure 17a and b).

Figure 17 mode conversion on rivets: a) stiffener with all rivets, b) one rivet removed; excitation frequency 200 kHz.
